# HOUSES

ARCHITECTURAL CHALLENGES AND SOLUTIONS

## BY DESIGN

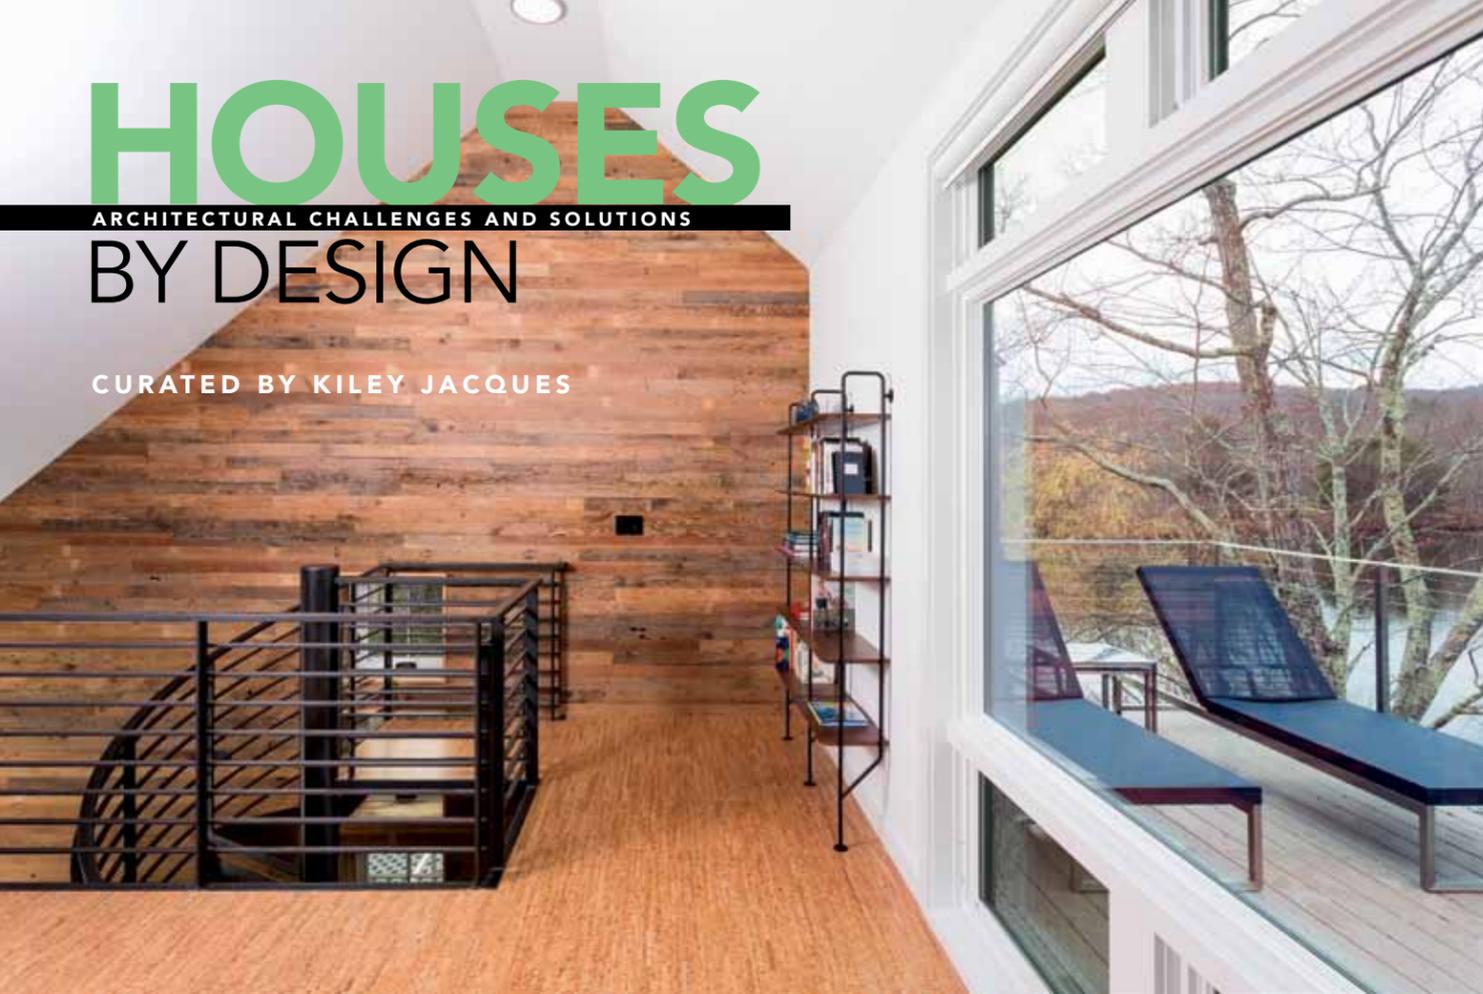
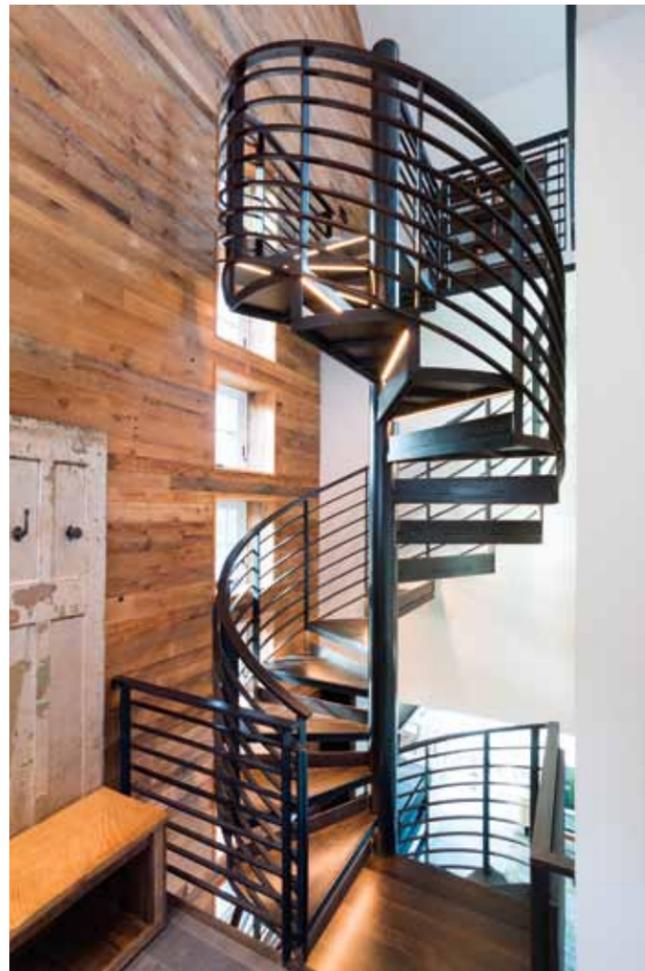
The construction of this 1500-sq.-ft. net-zero-energy home by Red House Design included a number of logistical challenges posed by the 60-ft. by 75-ft. lakefront lot. The site had a tangled web of setback incursions, lakefront/shoreline restoration requirements, surface/runoff water and silt mitigations, and maximum site-disturbance restrictions. Their first step was to retain a grandfathered existing structure through the entitlement process. With it, the house could be rebuilt with a vertical design on the same 25-ft. by 25-ft. footprint on the nonconforming lot. This enabled the inclusion of an advanced septic system and a combination geothermal/domestic water well.

Then came the challenge of how to get a custom-fabricated steel spiral stair with integrated lighting into the 6-ft. by 6-ft. vertical shaft connecting the three floors. The solution was to build a removable section of roof over the shaft. Come time, the build team was able to hoist the stair over the trees, through the roof, and into place without damaging any interior surfaces.

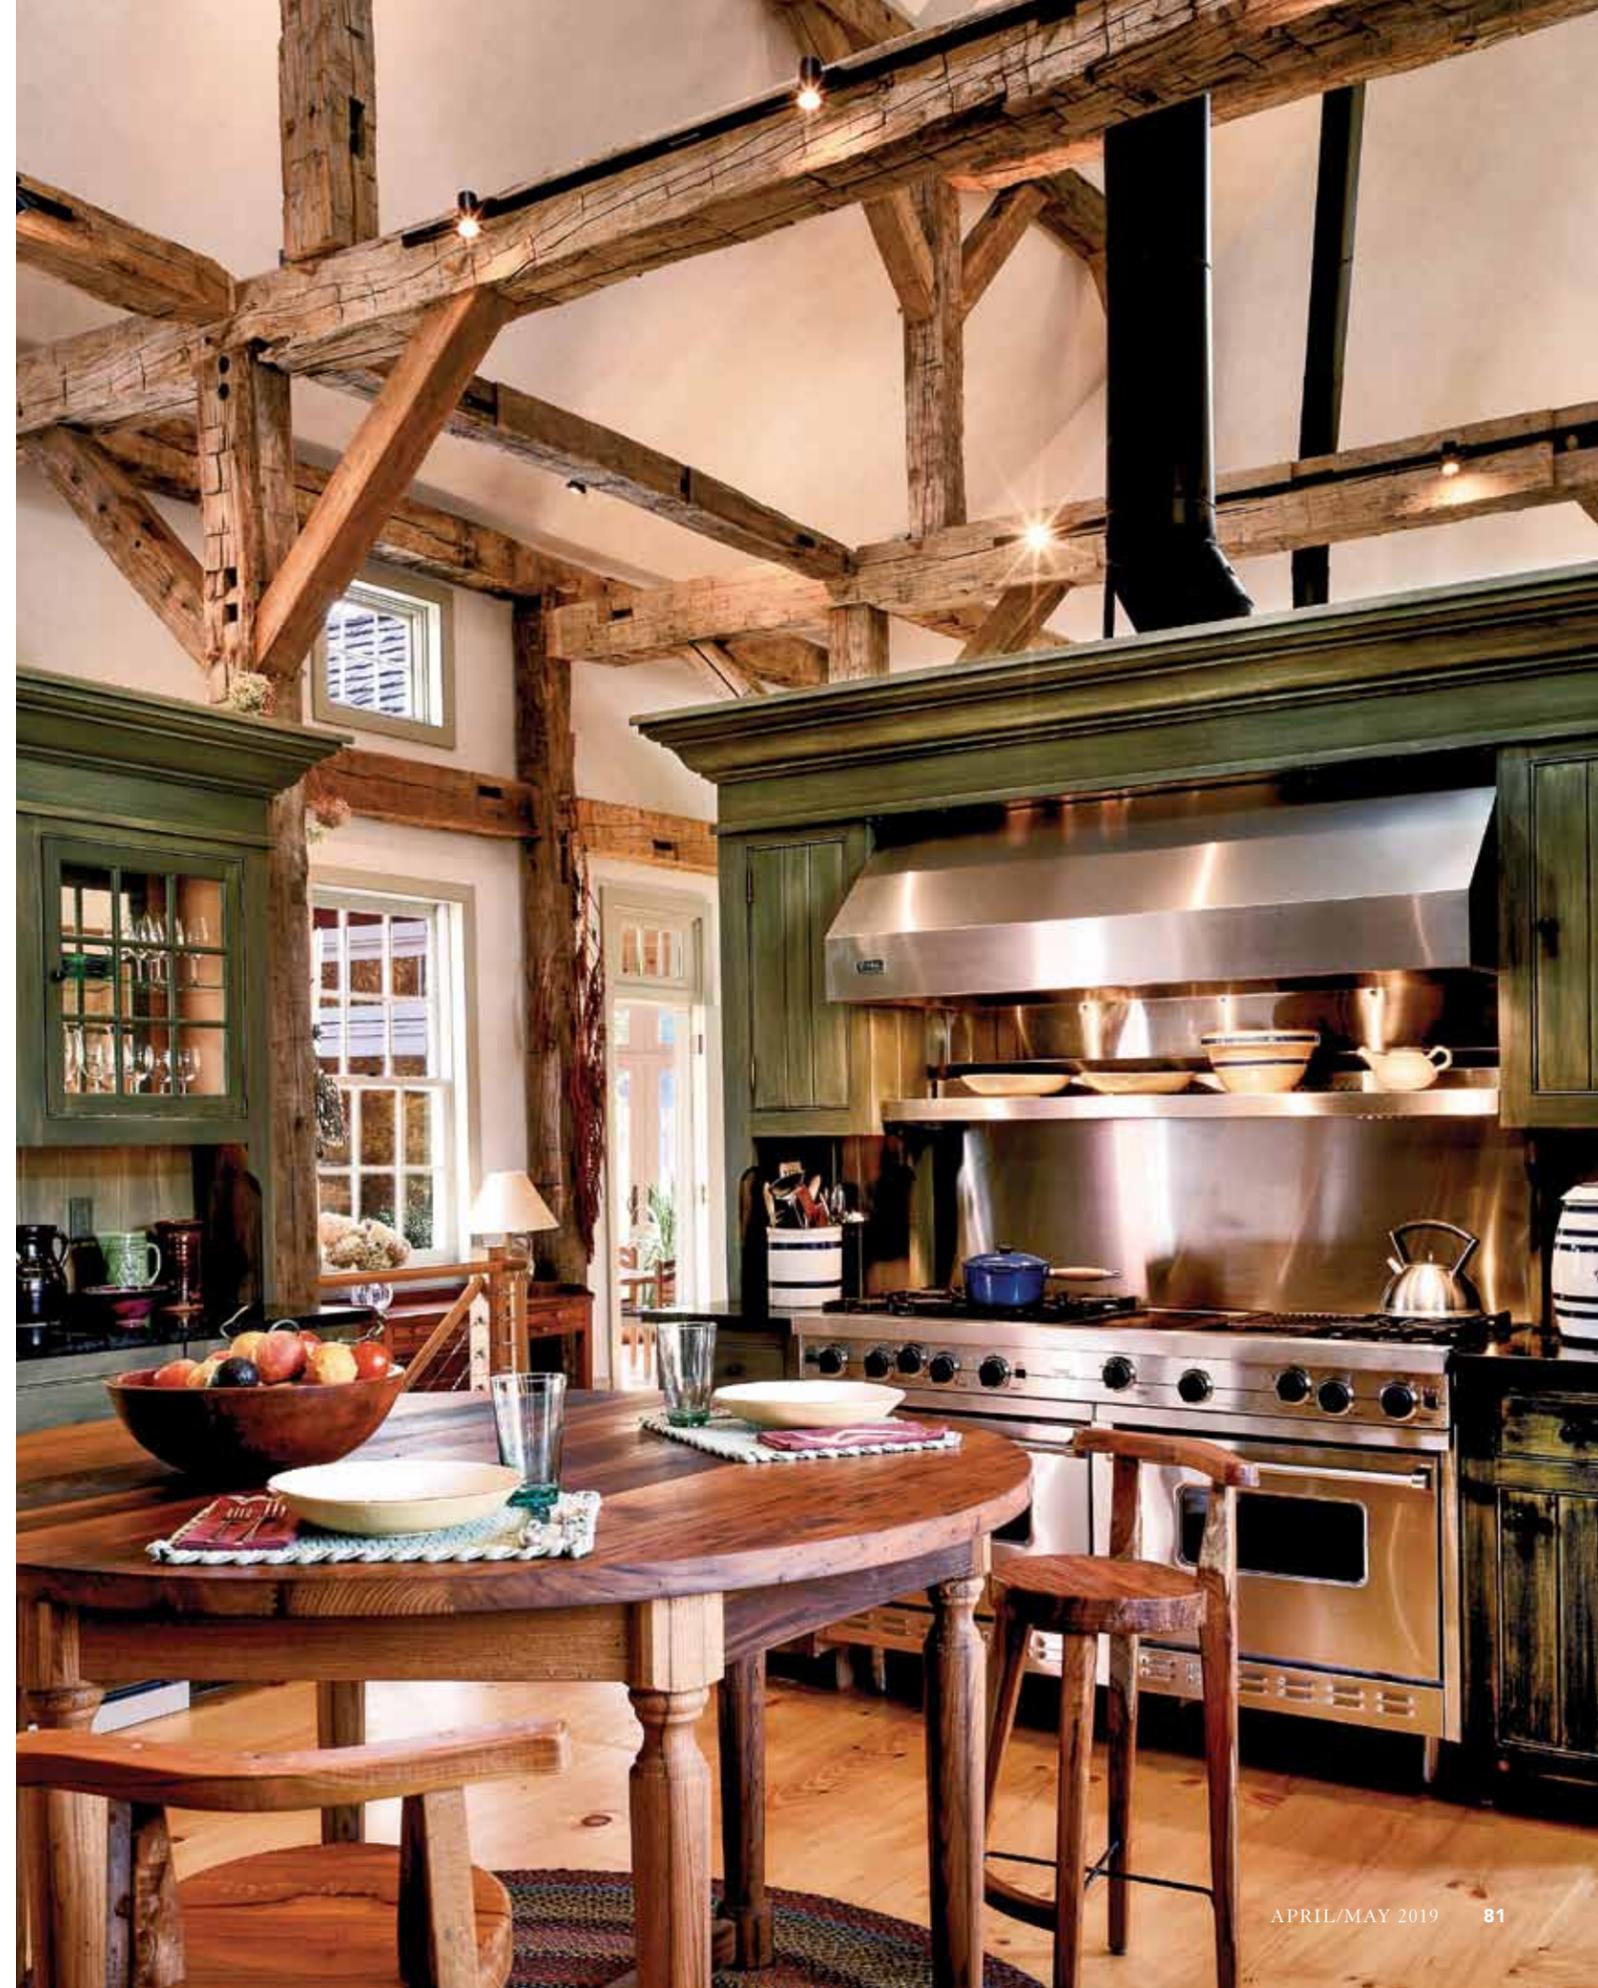
Originally, the homeowners wanted to transform their antique barn into a home. Because it proved structurally unsound, they hired Haver & Skolnick Architects to build a new house in its image. Working within the parameters of a historic district meant the exterior needed to closely resemble the original building. The primary design challenge was to create interior spaces within a vast space that allowed the salvaged hand-hewn timber frame to stand exposed. The solution was to create a central kitchen defined by freestanding cabinetry centered around a circular chestnut island. The cabinetry also delineates the living and dining areas while maintaining the integrity of the original barn's interior. Another piece of the puzzle was to find a worthy use for the iconic and prominent silo. At ground level, it serves as a dramatic entry hall with a soaring 30-ft. ceiling. Suspended above, a floating stair climbs to the top, where the architects used a continuous glass perimeter to transform the space into an observation tower. The iron-banded form is visible throughout the house.

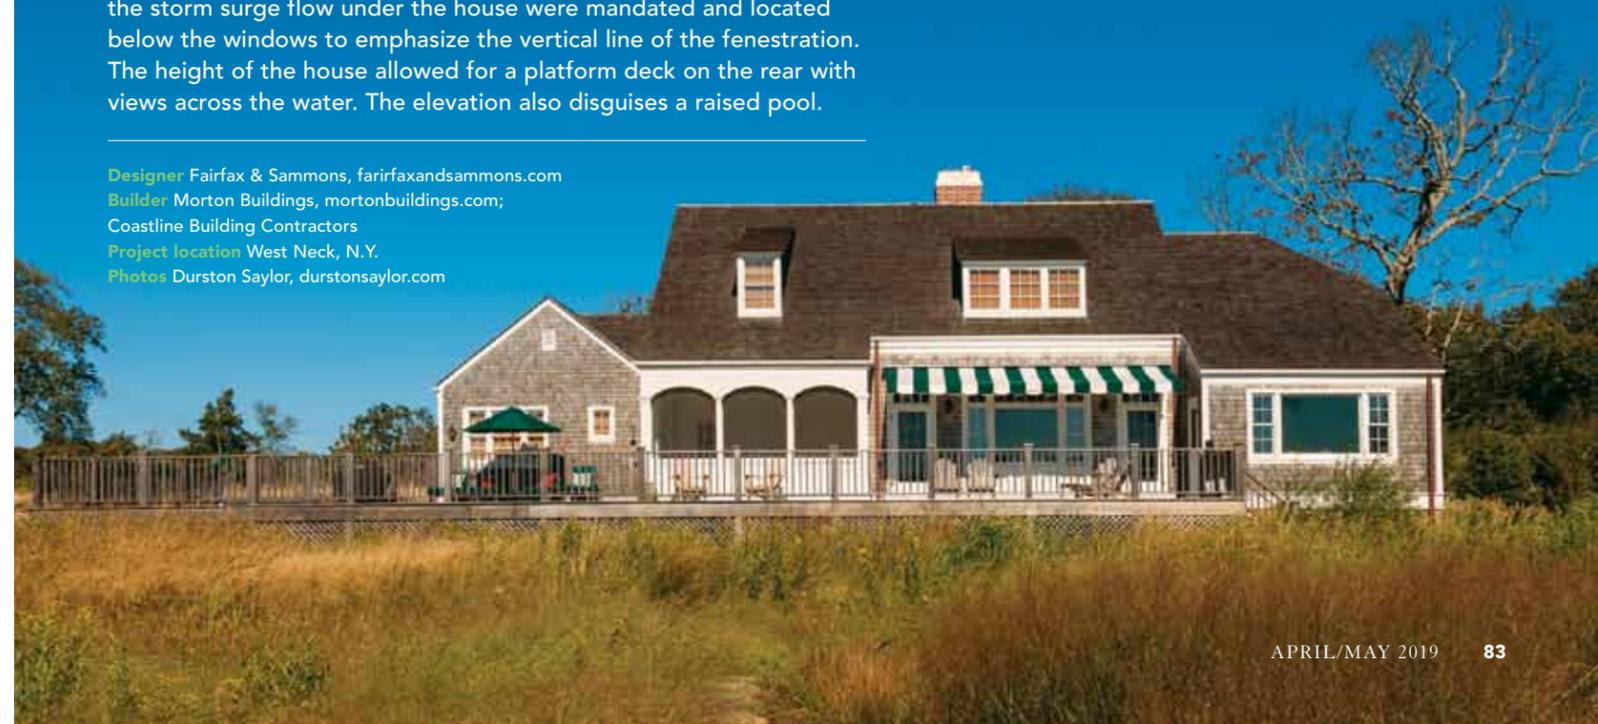
The main challenge posed by this site had to do with its proximity to Long Island Sound. Recently amended FEMA regulations specify new builds be 13 ft. above mean tide. Because the grade here is at 6 ft., Fairfax & Sammons had to raise the finished floor by 7 ft. The difficulty was trying to make a Cape-style house—which would normally sit right on the ground—look natural when elevated. The treatment of the exposed foundation wall was paramount. They took advantage of the required mounded septic system by bringing it up to one corner of the house and surrounding it with retaining walls. This provided visual continuity to the exposed foundation wall, which was faced with handmade brick in Flemish bond. Openings to let the storm surge flow under the house were mandated and located below the windows to emphasize the vertical line of the fenestration. The height of the house allowed for a platform deck on the rear with views across the water. The elevation also disguises a raised pool.
